FNAL experience with thin beam windows

NBI03
November 7-11, 2003
FNAL thin beam windows
Jim Hylen / FNAL
Page 7

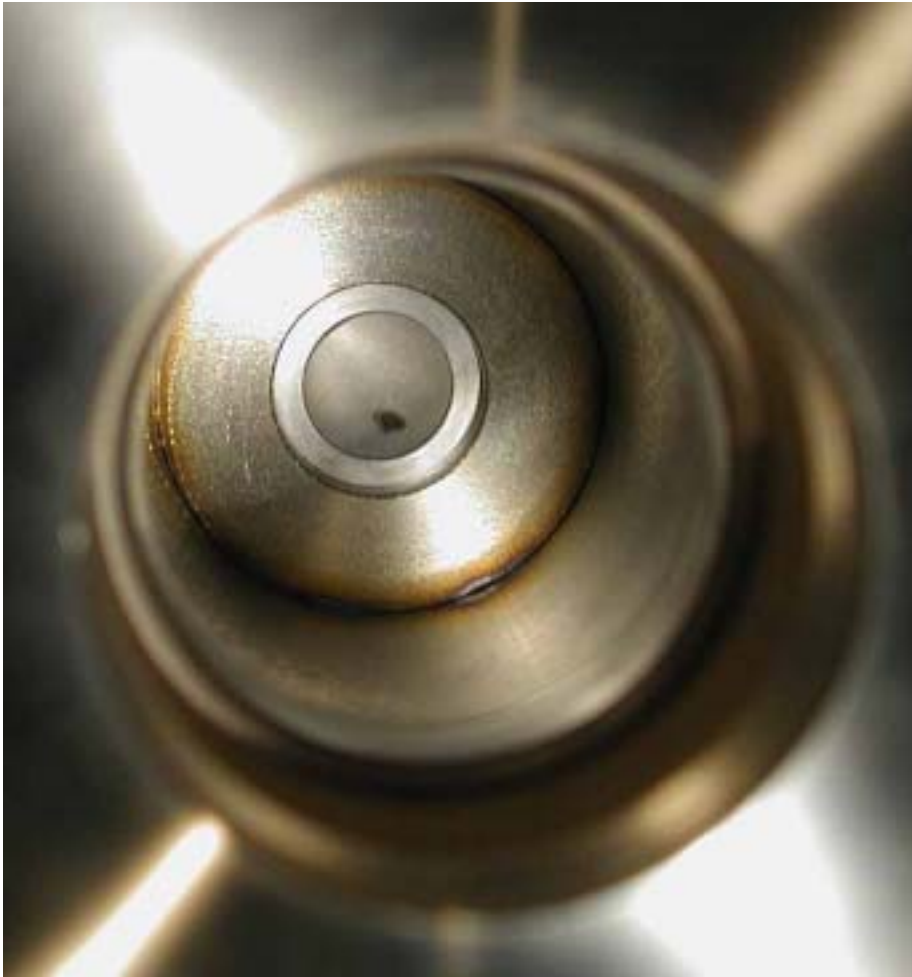
Beryllium window on proton beamline for pbar production

in beam for about a year now
0.3 mm RMS spot size
~ 5×10^{12} protons/pulse

accumulated about 1.7×10^{19} protons
with no failures

can see spot where beam heating
has caused oxidation

having to clean-up mixed waste
(after a wrench-meets-window
incident NOT at pbar) induced
installation of a catcher
(pair of Ti windows with air break
where spot size is 4 mm)
which would limit spread of
Be contamination upstream
in case of catastrophic window failure

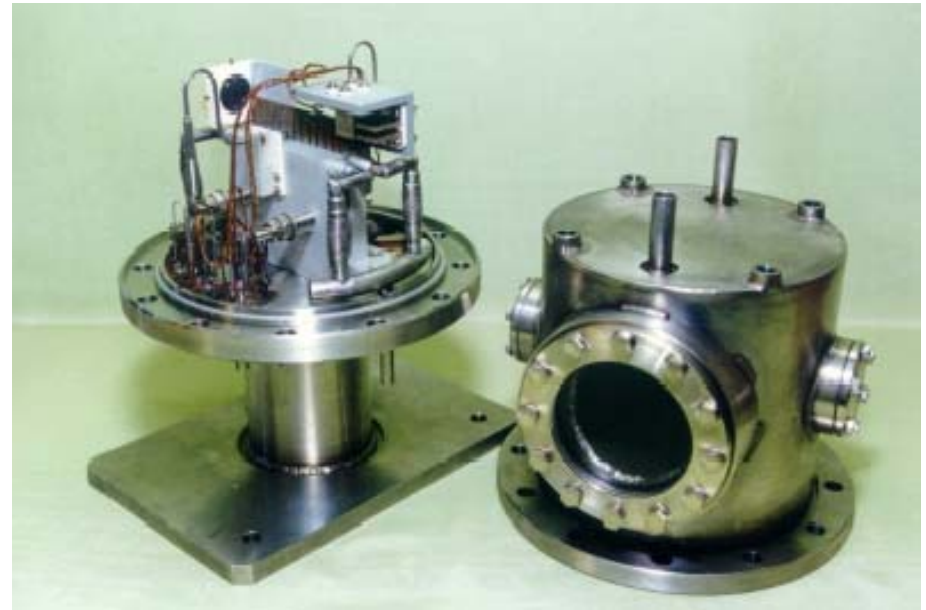
NuMI Prototype Target Test target can Beryllium window

During the NuMI target prototype test, an even more intense spot was generated for a short period of time

- 10^{13} protons/ 10 μ sec pulse
- 0.21 mm x 0.16 mm spot size

No visible damage to beryllium window
(however target was not run at a high vacuum, only a few milli-torr, so a small leak could have gone unnoticed)

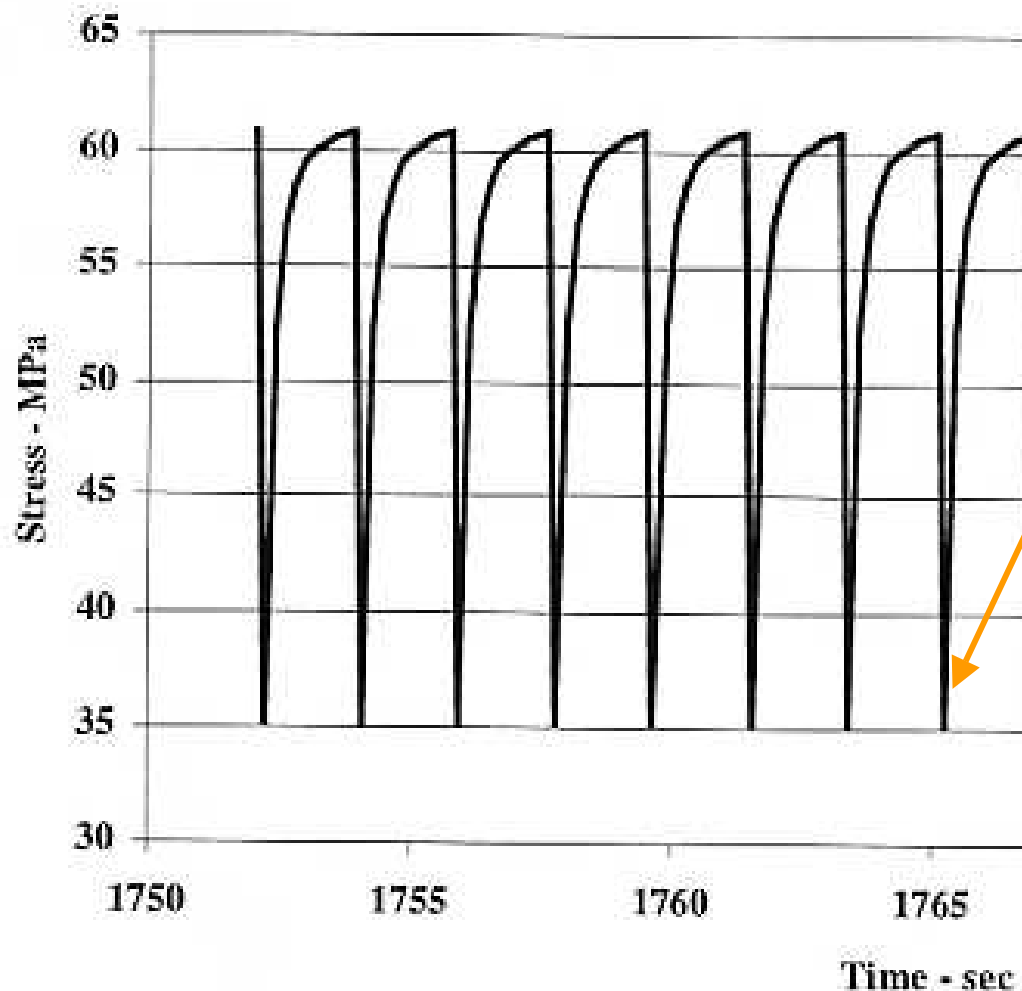
Decay Pipe Window

(accident condition – beam misses target)

Accident condition:

4×10^{13} proton/spill
~2.5 mm RMS beam spot

Air pressure pre-stresses
vacuum window

Beam heating temporarily
reduces stress at center of window

Normal running condition:

$\sim 4 \times 10^{12}$ proton/spill through target
~11 mm RMS beam spot at window

Expect radiation damage at
 $\sim 4 \times 10^{19}$ proton/mm²
~ one century of running

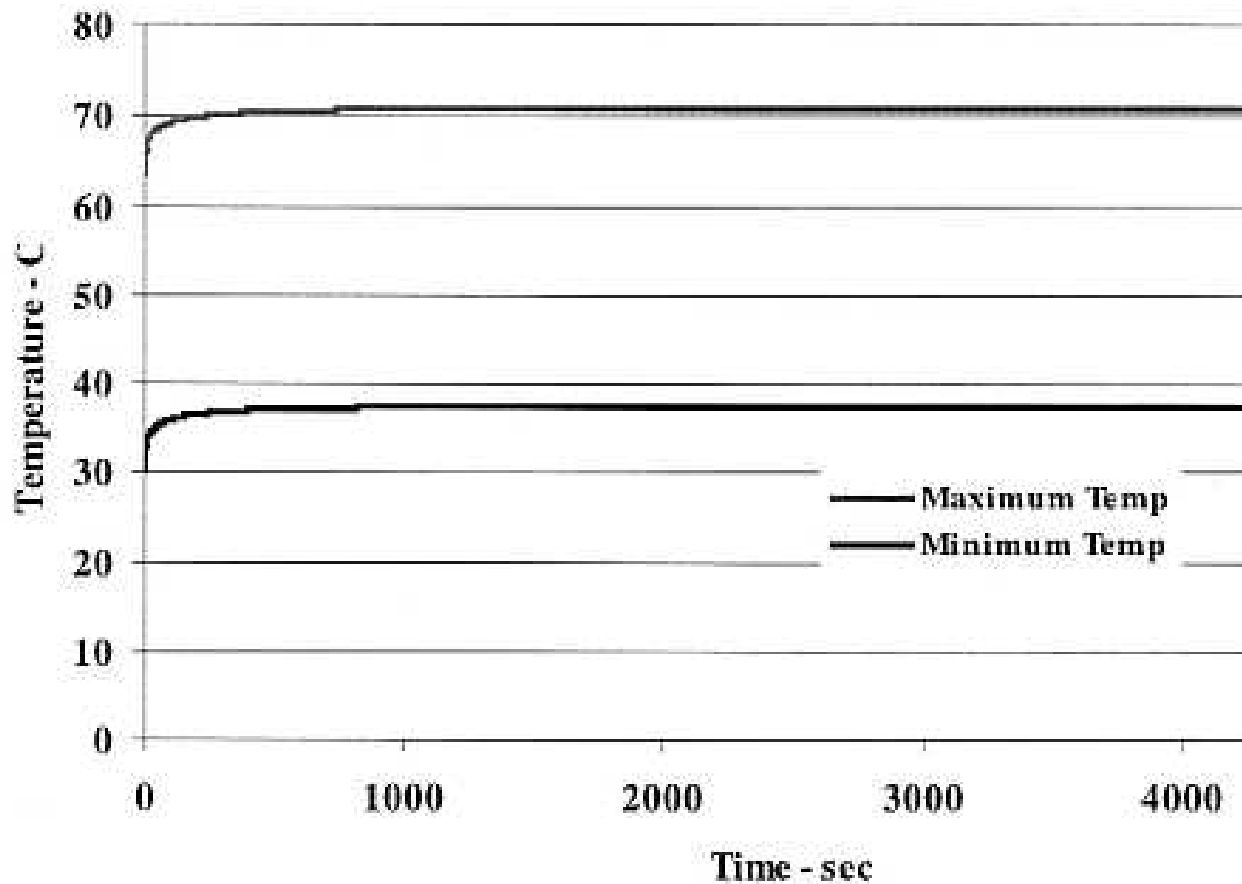
Figure 4. Temperature Rise at Center of Thin Head

Temperature rise after
many beam cycles
is small

(1 pulse / 1.87 seconds)
