The MiniBooNE Target

NBI03, Tsukuba, Japan.

MiniBooNE Overview

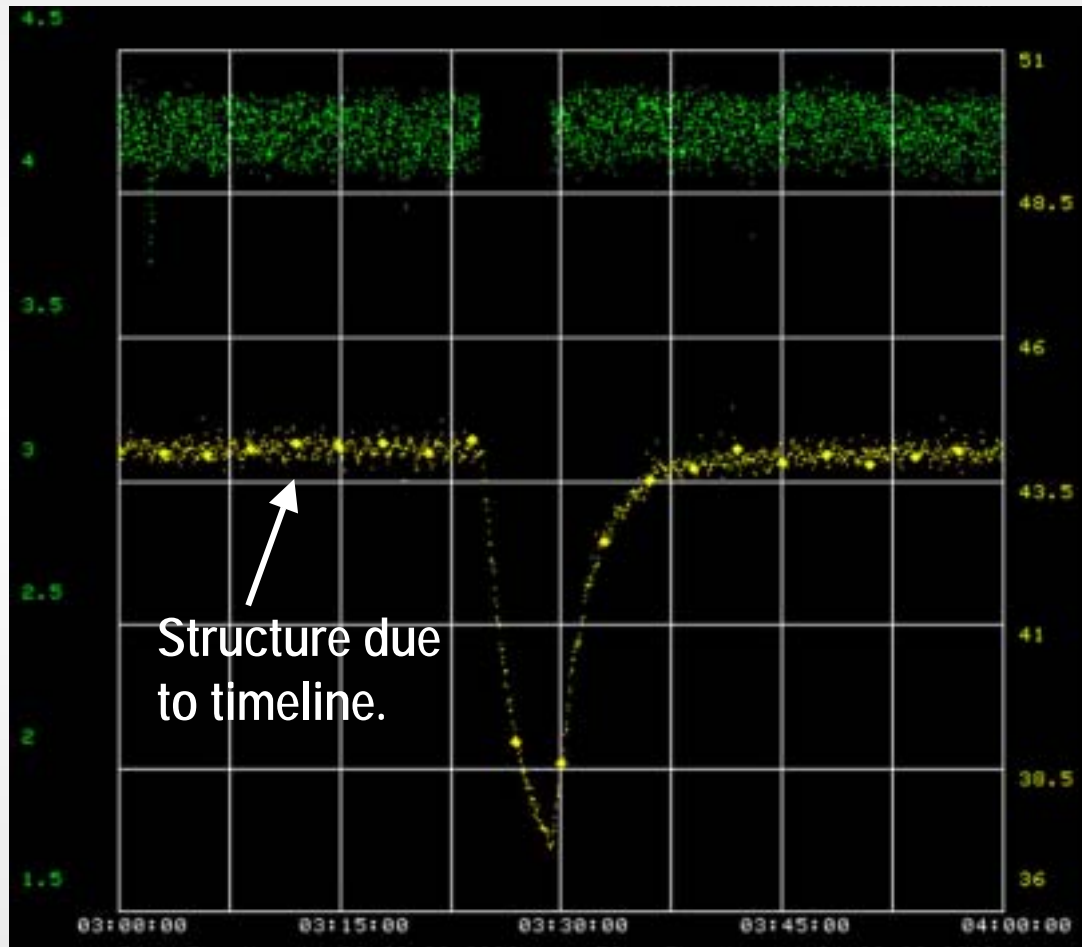
Target Temperature

The target temperature is very sensitive to whether the beam is on target.

It's not the only measure, but can be used as a powerful cross check of the BPMs and multiwires.

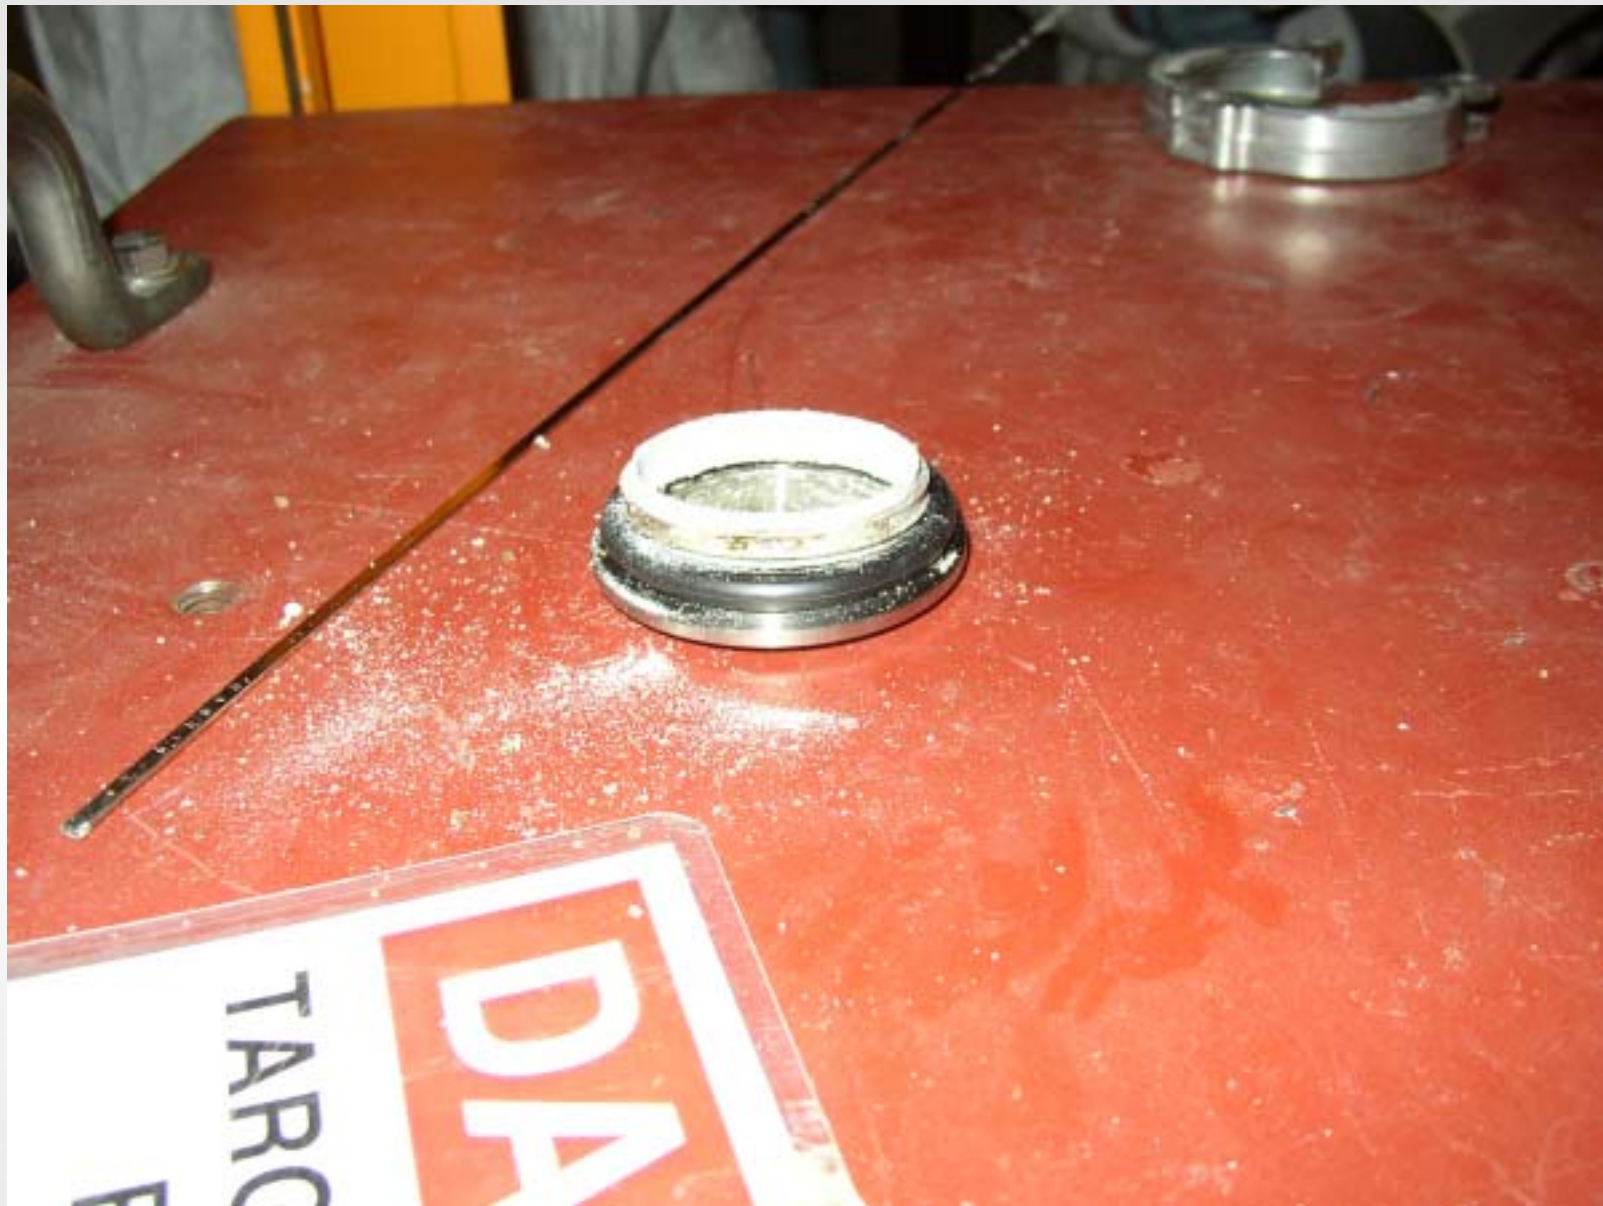
Be in the Air Scare

- Fittings around 3 of the monitoring devices were found to be compromised, likely due to radiation damage to organics used in the seals (Teflon). These leaks were all downstream of the HEPA filter. These leaks could have been the cause of the high readings. They have now been fixed.
- The HEPA filter was inspected and replaced. Old filter showed no visible signs of radiation damage.
- “Grit” was found in the upstream pipe into the HEPA filter. Chemical analysis showed no Be, but Al_2O_3 and Cu were present. The origin of the grit is unknown, but suspected to be the horn box.
