CNGS Horns: Status

NBI 2003 – KEK, Japan 7-11 nov. 2003

Presented by Sandry Wallon

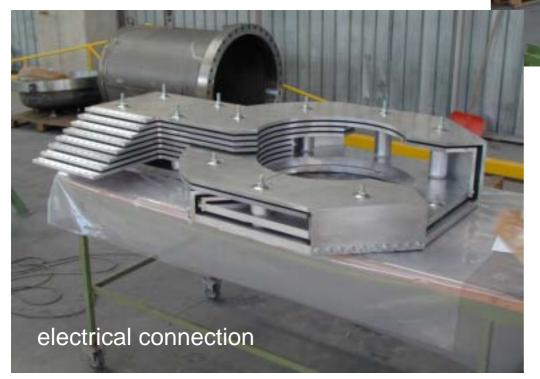
outer conductor

Large parts

Horns 1 et 1b : done Reflector : done

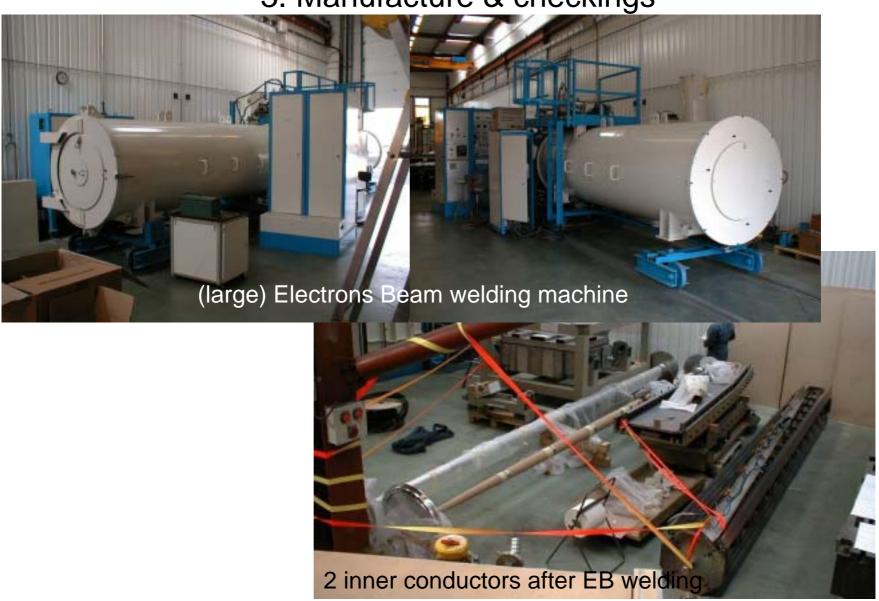
inner conductors

Horn flanges' checkings (after machining)

- → Ultrasonic
- \rightarrow X ray
- → geometrical

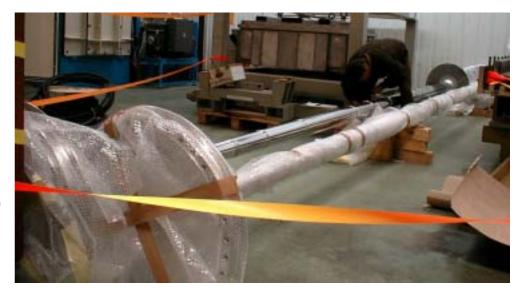
Horn inner conductors' checkings (after welding) → X ray (for welds)
